ABNORMAL CRACKS LED TO PREMATURE DECOMMISSIONING OF BOILER FEED WATER EXCHANGER – WHAT HAPPENED AND WHY?

BY: ANA BENZ *Materials Engineer, IRISNDT*

A small leak from top tubesheet-to-tube welds prompted further inspection of the 1¼Cr- ½Mo Ammonia Converter Boiler Feed Water (BFW) Exchanger during a planned shutdown. Further cracks were identified in the top channel to tubesheet butt weld that operated at 700 °F. After grinding halfway through thickness with these cracks still being present, excavations of the 2 1/8” thick shell were stopped. As well, attempts to repair the top tubesheet-to-tube welds resulted in further cracks developing. The BFW exchanger was scrapped after being in service for 7 years. In contrast, previous exchangers in this service had operated without known cracks for more than 15 years. The findings as to the causes and potential measures to obtain a better service life are presented below.

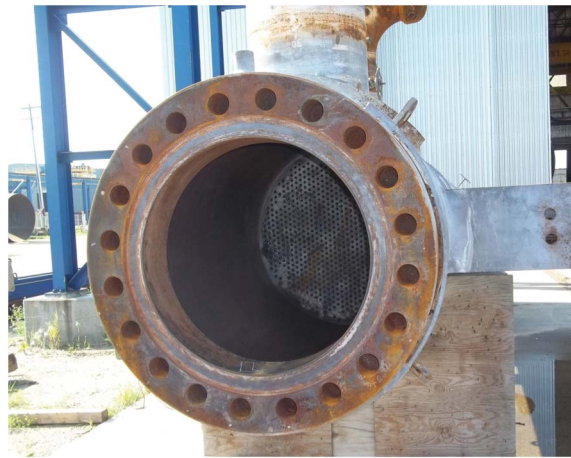
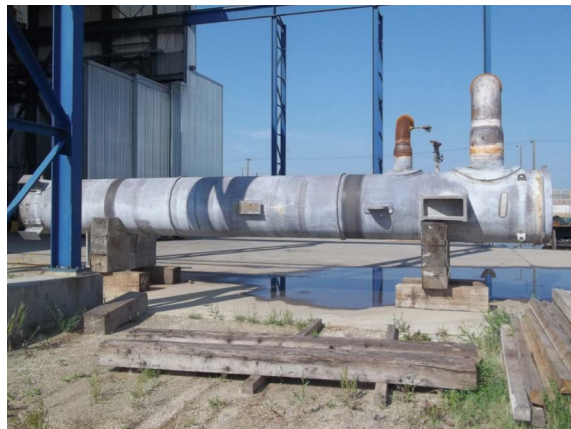
Figure 1(a) and (b). Vessel Images

The type of vessel is illustrated in **Figures 1(a) and 1(b)**. The photographs show the vessel's Inside Diameter (ID) surfaces after attempting to excavate the cracks on the top channel to tubesheet weld. Magnetic particle inspections showed cracks mainly transverse to the welding direction. The cracks are mainly confined to the deposited weld metal (DWM). See **Figures 2-4**.

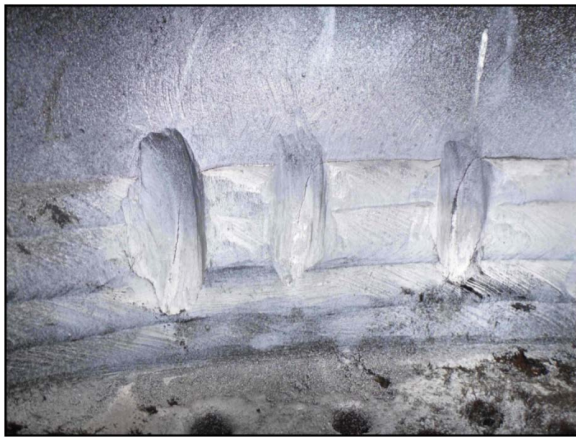
Figure 2. Cracks in the vessel after partial excavation.

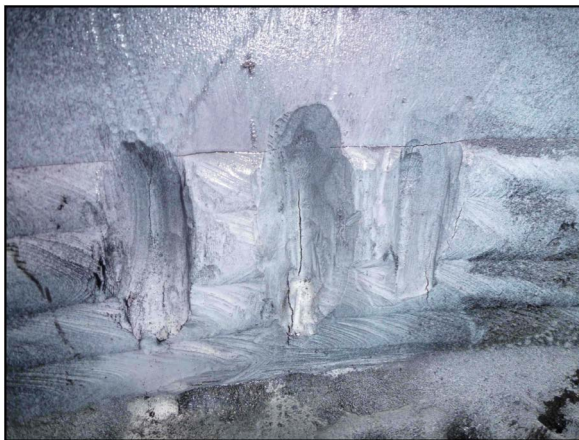
Figure 3. Cracks in the vessel after partial excavation.

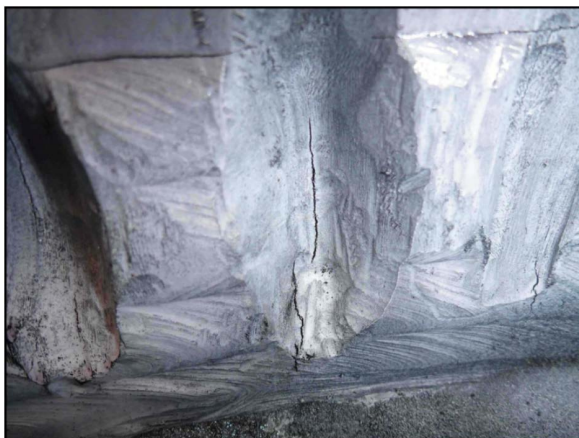
Figure 4. Close-up of cracks in the vessel after partial excavation.

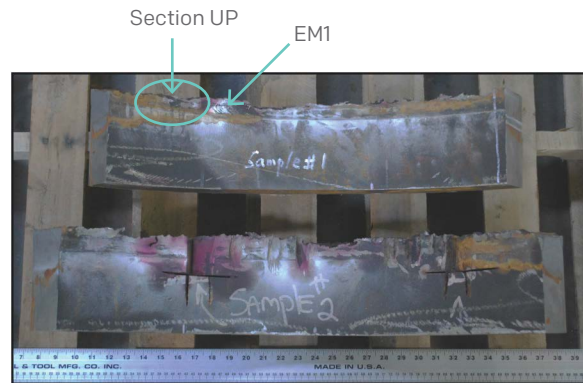
Figure 5. Top Channel sections, ID.

Prior to being received for examination, most of the cracks were excavated. The DWM was flame cut and mainly removed when attempts were made to join a new channel to the tubesheet. In other words, most of the cracked zones had been eliminated or subjected to localized heat. The remnants had mainly channel Parent Metal (PM) with some flame cut formerly welded surfaces. See **Figure 5**.

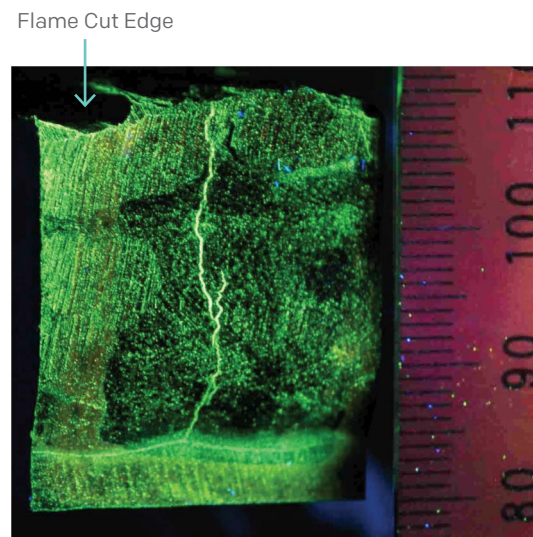
Figure 6. Magnetic particle inspection of ID, Section UP mainly DWM is shown.

Wet fluorescent magnetic particle inspection (MPI) showed a crack running perpendicular to the DWM in Section UP identified in **Figures 5 and 6**. The crack was opened and the fracture surfaces are shown in **Figure 7**. The fracture fans out from the ID (the process side). Next to the flame cut end, it is whiter. Away from the flame cut end and next to the inside surface, the fracture has a brittle and rough interdendritic appearance.

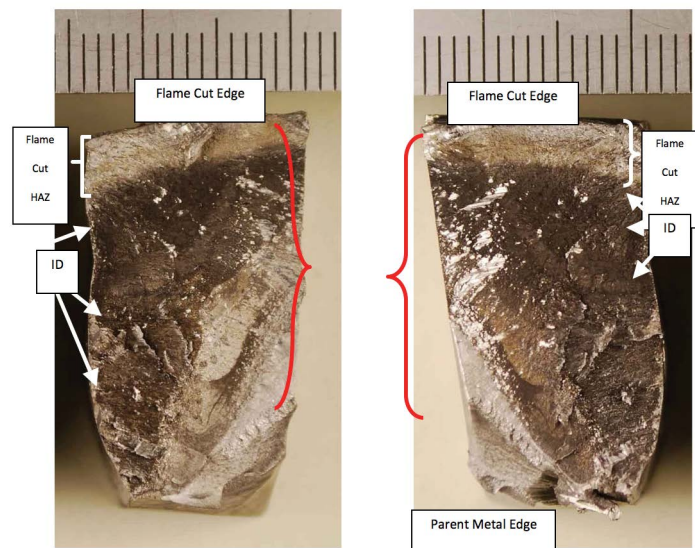
Figure 7. Fracture Surface Overview, Section UP. Matching sides of the fracture surface are shown side by side. The red brackets frame the portion of the fracture that propagated through deposited weld metal.

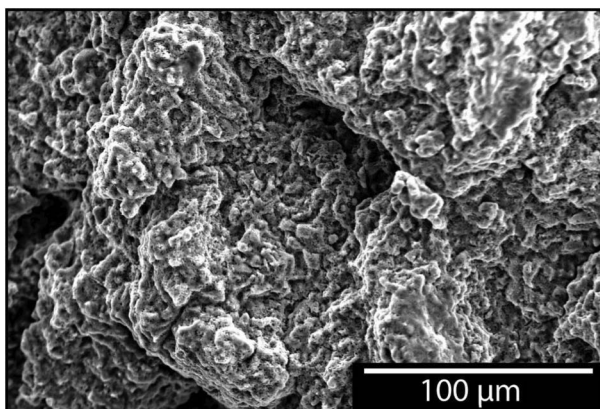
Prior to receiving the parts shown in **Figures 5 - 7**, a boat sample was extracted from the top channel to tubesheet butt weld crack. The crack was examined with the SEM. Without cleaning, the fracture faces appeared to have an intergranular appearance, and an adherent scale (See **Figure 8**). The scale mainly contained large amounts of Fe, and O with smaller amounts of Cr, Mn, and Si (See **Figure 9**). It mainly contained iron oxides.

Figure 8. Fracture surface Secondary Electron Microscopy (SEM) image.

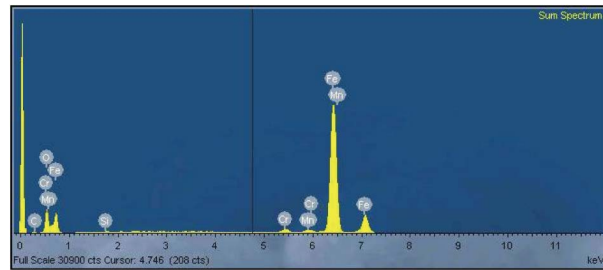
Figure 9. EDX Spectrum of the surface in **Figure 8**. image.

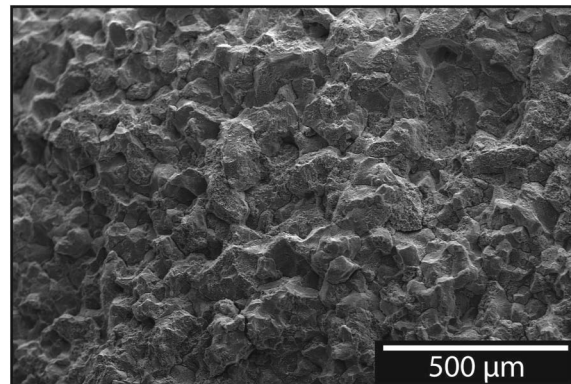
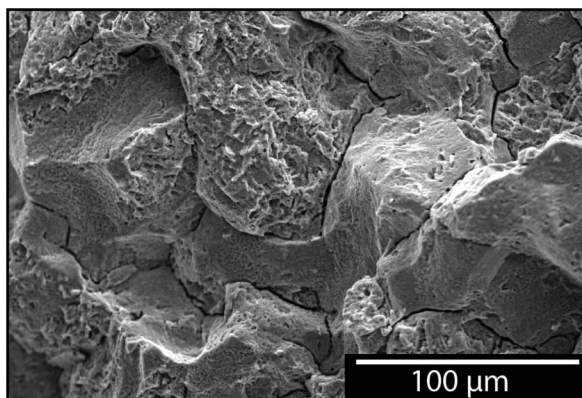
The fracture surface is shown after cleaning with Alcanox detergent in an ultrasound cleaner. It is intergranular (See **Figures 10 and 11**). EDX analysis of the surface indicates the surface had large amounts of Fe, with smaller amounts of, Mn, Cr, Mo, and Si (See **Figure 12**). These are all constituents of the 1.25 Cr + 0.5 Mo steel Deposited Weld Metal (DWM).

Figure 10. Sample A2 SEM image of the cleaned face.

Figure 11. Sample A2 SEM image of the cleaned face at higher magnification.

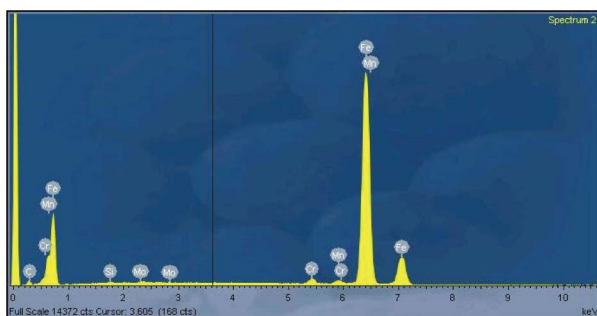
Figure 12. EDX Spectrum of the fracture surfaces shown in **Figures 10 and 11**.

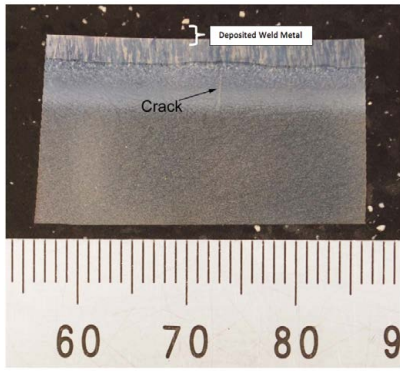
Figure 13. Metallographic Cross-Section EM1 Overview.

- Sample EM1 [See **Figure 5** for location] from the top channel to tube sheet weld contains a ground section of DWM, some of its HAZ and some of the PM beneath it. This cross-section is parallel to the welding orientation (See **Figure 13**).

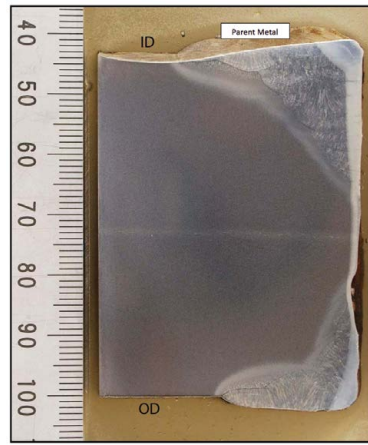
Figure 14. Overview of Top Channel to Top Tubesheet Sample TC1.

- Sample TC1 from the top channel to tube sheet weld contains some PM, some DWM and some Heat Affected Zone (HAZ) associated with the flame cutting. This cross-section is perpendicular to the welding orientation (See **Figure 14**).
- Sample BC1 from the bottom channel to tube sheet weld contains some Bottom Channel PM, some Bottom Channel Heat Affected Zone (HAZ), some DWM, some Tube Sheet HAZ and some Tube Sheet PM. This cross-section is perpendicular to the welding orientation (See **Figure 15**).
- Metallographic Sample EM1 has a crack running from the ID through the HAZ and into the PM (See **Figure 16**). Through the DWM, the crack is interdendritic. Through the HAZ and the PM the crack is intergranular (See **Figure 17**). The crack has minimal branching from the ID toward the OD. The crack surface has minimal to nil deposits.

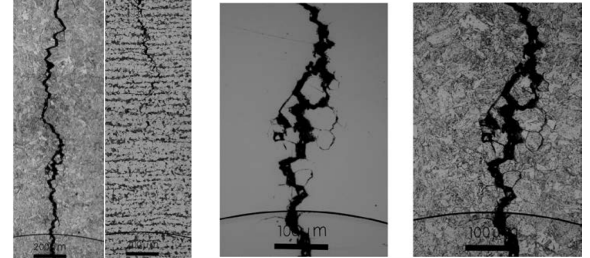
Figure 17. EM1 Crack along the HAZ, 4% Nital Etch on the right.

The transverse cracks in the top channel to tubesheet butt weld are likely associated with creep and temper embrittlement. This conclusion was drawn because the cracks are:

Excessive hardness values contributed to the development of these cracks. This is concluded since:

- The cracks are always located in hardened zones. The hardened zones have hardness values that exceed the 235 HV10 maximum recommended by API RP 934-C.
- 1¼Cr-½Mo steel is prone to developing cracks in this type of service when it has areas of high stress concentration.⁴ The localized hard zones are areas of high stress concentration.
- The bottom channel to tubesheet butt weld hardness values are all below the API RP 934-C maximum recommended value and this weld did not crack.

- Rigorous control of the post weld heat treatment is fundamental.
- Verification of the hardness of the process side heat affected zones is important. Meticulous surface preparation is required to obtain meaningful field hardness measurements.

- The PWHT of replacement vessels should be monitored rigorously. The ID PWHT temperatures require monitoring.
- The PWHT of the shell joints and the tubesheet to tube welds require monitoring.
- Verify that the process side heat affected zones meet the hardness requirements specified in API RP 934-C.

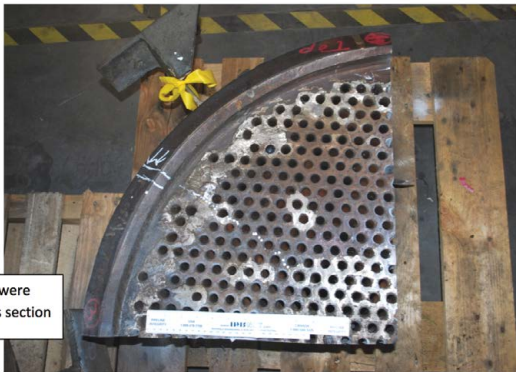
Figure 23. Top channel quarter section, top view

The surfaces exposed by longitudinal cuts on the top channel tubesheet were inspected with color contrast MPI. Some of the welds between the tubes and the top tubesheet had MPI crack-like indications (See **Figures 23 and 24**).

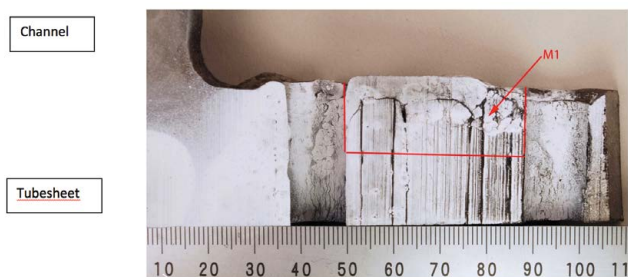
Figure 24. CM1 – Location, Top Tube Sheet (Near Top Channel).

- Sample CM1 from a top tubesheet to tube weld, near the channel ID (See **Figure 24**).
- Sample CM2 from a top tubesheet to tube weld near the tubesheet center (See **Figure 25**).

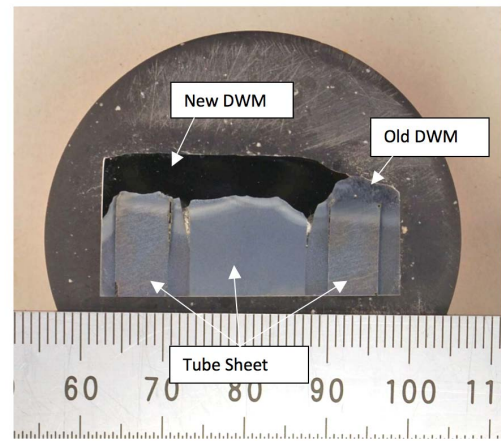
Figure 26. CM1 Top Tube sheet (Near Channel) Overview.

Sample CM1 has DWM from original fabrication referred to as “Old DWM.” The samples also have “New DWM” deposited in 2012 during attempts to repair the tube to tubesheet leaks (See **Figure 26**). The Old DWM has multiple mainly parallel intergranular/interdendritic cracks (See **Figures 27 and 28**). The cracks are typically parallel to the intersection between the tube and the tubesheet. The cracks arrest at the fusion line between the Old DWM and the New DWM.

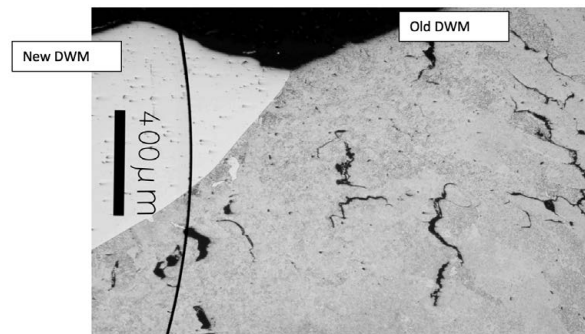
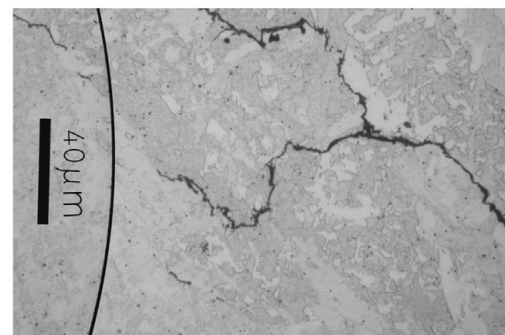
Figure 27. CM1 Top Tube Sheet (Near Channel) Cracking in Old DWM, 2% Nital Etch.

Figure 28. CM1 Top Tube Sheet (Near Channel) Cracking in Old DWM, 2% Nital Etch.

These cracks are likely associated with creep and temper embrittlement since they are:

- Interdendritic/intergranular as reported for creep cracks.⁵
- Typically parallel to the intersection between the tube and the tubesheet. This is an area subjected to high welding related stresses where creep damage can develop.
- Only present on the top tubesheet welds. They are not present on the bottom tubesheet to tube welds which operated at temperatures lower than the top sections.

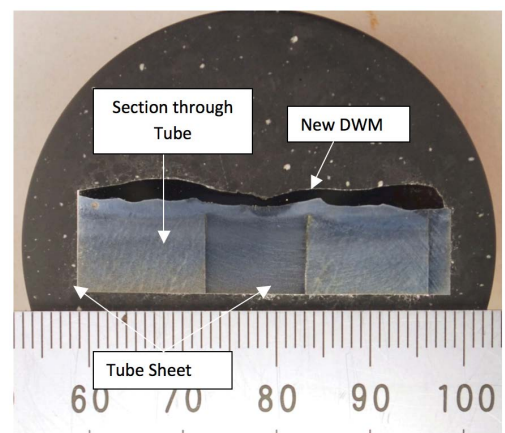
Figure 29. CM2 Top Tube Sheet (Near Centre) Overview.

The Old DWM microstructure comprises ferrite and tempered martensite and/or bainite. The New DWM was not etched by 2% Nital. Reportedly, it was a high nickel electrode consistent with the metallographic appearance of the deposited weld metal. Sample CM2 has multiple mainly parallel intergranular/interdendritic cracks in the Old DWM. The cracks are typically parallel to the intersection between the tube and the tubesheet. They arrest at the fusion line between the Old DWM and the New DWM.

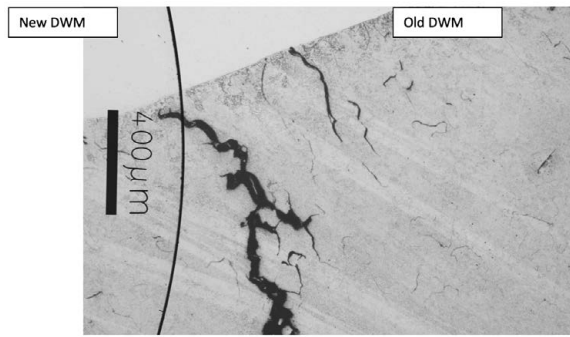
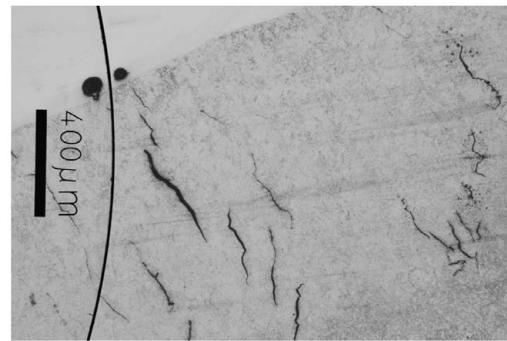
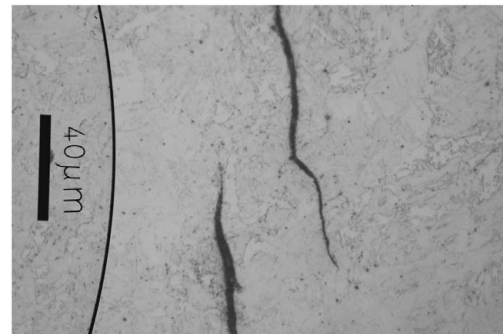
The Old DWM microstructure comprises ferrite and tempered martensite and/or bainite. The New DWM was not etched by 2% Nital. Reportedly, it was a high nickel electrode consistent with the metallographic appearance of the deposited weld metal (See **Figures 29 – 32**).

Figure 30. CM2 Top Tube Sheet (Near Centre) Cracking in Old DWM, 2% Nital Etch.

Figure 31. CM2 Top Tube Sheet (Near Centre) Cracking in Old DWM, Porosity in New DWM, 2% Nital Etch.

Figure 32. CM2 Top Tube Sheet (Near Channel) Cracking in Old DWM, 2% Nital Etch.
